Product Change Notification - SYST-25MCXX581

ERRATA - dsPIC33EPXXGS202 Family Silicon Errata and Data Sheet Clarification

dsPIC33EPXXGS202 Family Silicon Errata and Data Sheet Clarification

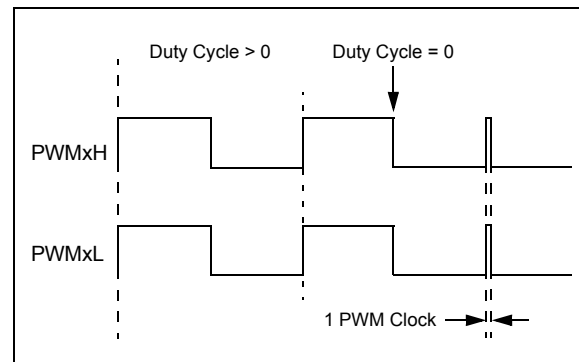
FIGURE 1: EXAMPLE FOR REDUNDANT OUTPUT MODE

In the Redundant Output mode (`IOCONx[11:10] = 0b01`) and Push-Pull Output mode (`IOCONx[11:10] = 0b10`), with the Immediate Update Enable bit disabled (`PWMCONx[0] = 0`), when the Duty Cycle register is updated from a non-zero value to zero, a glitch pulse of a width equal to one PWM clock will appear at the next PWM period boundary, as shown in Figure 1 (for the Redundant Output mode). The Duty Cycle register refers to the `PDCx` register if `PWMCONx[8] = 0` or the `MDC` register if `PWMCONx[8] = 1`.

If the application requires a zero duty cycle output, there are two possible work around methods:

1. Use the PWM override feature to override the PWM output to a low state instead of writing to the Duty Cycle register. In order to switch back to a non-zero duty cycle output, turn off the PWM override. The override-on and override-off events must be timed close to the PWM period boundary if the `IOCONx` register has been configured with `IOCONx[0] = 0` (i.e., output overrides through the `OVDDAT[1:0]` bits occur on the next CPU clock boundary).
2. Enable the Immediate Update Enable bit (`PWMCONx[0] = 1`) while configuring the PWMx module (i.e., before enabling the PWMx module, `PTCON[15] = 1`). With the Immediate Update enabled, writes to the Duty Cycle register can have an immediate effect on the PWM output. Therefore, the duty cycle write operations must be timed close to the PWM period boundary in order to avoid distortions in the PWM output.

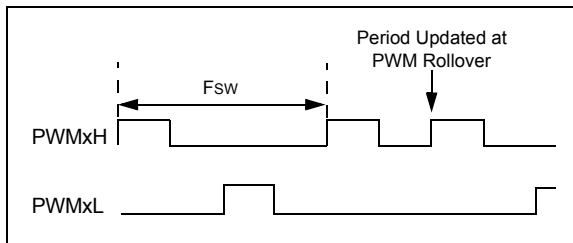
FIGURE 2:

When the PWM module is configured for Push-Pull mode (IOCONx[11:10] = 0b10) with the Enable Immediate Period Update bit enabled (PTCON[10] = 1), a write to the Period register that coincides with the period rollover event may cause the push-pull output logic to produce back-to-back pulses on the PWMx pins (Figure 2).

If the EIPU bit is set (PTCON[10] = 1), ensure that the update to the PWM Period register occurs away from the PWM rollover event. Use either the PWM Special Event Trigger (SEVTCMP) or the PWM Primary Trigger (TRIGx) to generate a PWM Interrupt Service Routine (ISR) near the start of the PWM cycle. The PWM Period register could be updated inside this ISR so that the period writes do not occur near the PWM period rollover event.

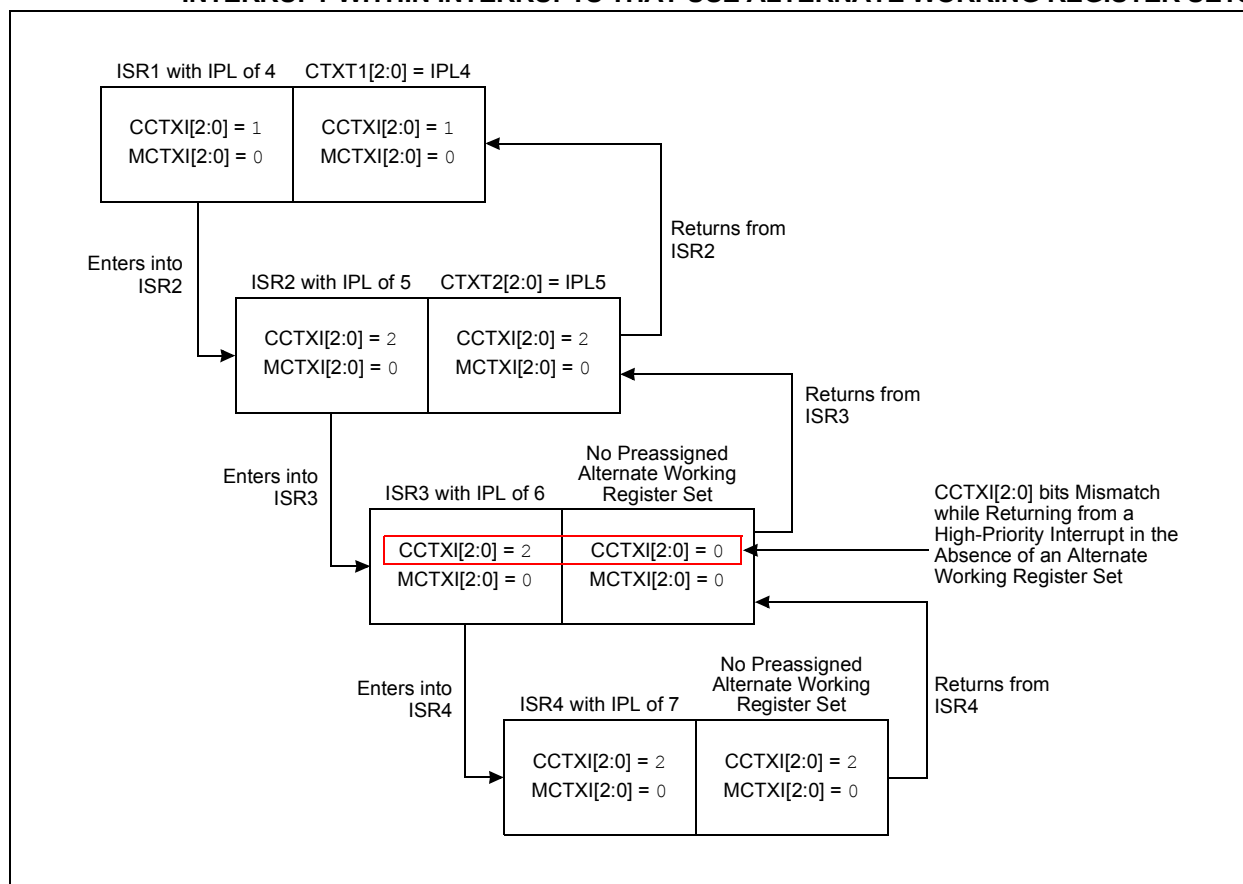
FIGURE 3: MISMATCH OF WORKING REGISTER SET WHEN NESTING MORE THAN ONE INTERRUPT WITHIN INTERRUPTS THAT USE ALTERNATE WORKING REGISTER SETS

Issue and work around are illustrated in [Figure 3](#) and [Figure 4](#), respectively. The figures show the status bits, `CCTXI[2:0]` and `MCTXI[2:0]`, after entering into an ISR from a lower priority ISR (left pane), and after returning to the same ISR from a higher priority ISR (right pane).

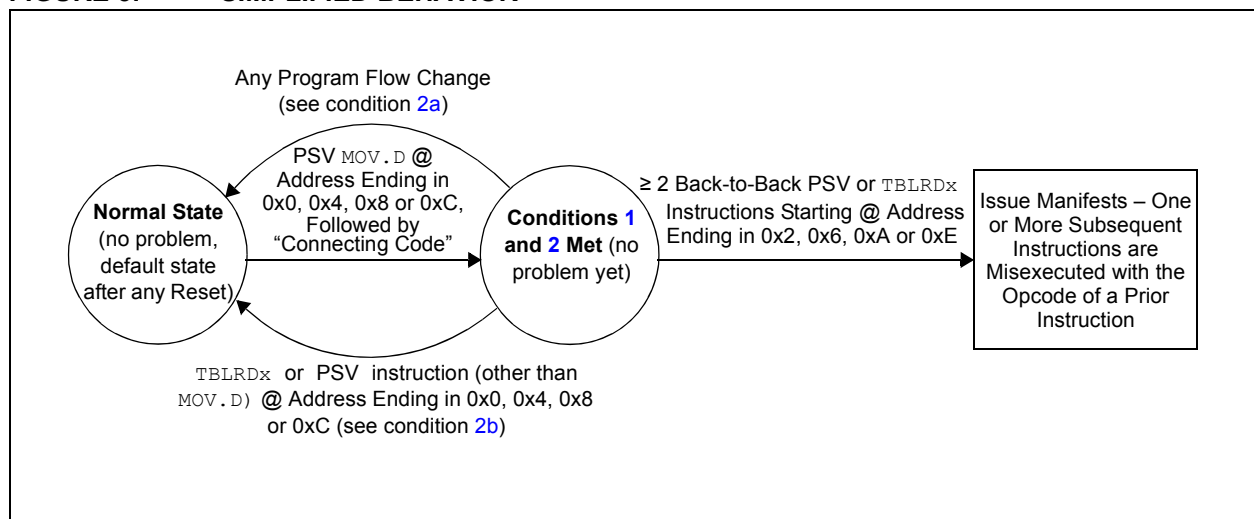
FIGURE 5: SIMPLIFIED BEHAVIOR

When two or more data Flash read instructions (via Program Space Visibility (PSV) read or table read) are executed back-to-back, one or more subsequent instructions can be misexecuted when all of the conditions in [Table 4](#) occur.

[Figure 5](#) provides an example of the effective behavior.

1. All instances of PSV `MOV.D` can be replaced with two PSV `MOV` instructions instead. Non-PSV `MOV.D` instructions acting on RAM/SFRs do not need to be modified; or
2. If not already present, a program flow change instruction (such as `BRA $+2`) can be inserted above back-to-back data Flash read sequences; or
3. Back-to-back data Flash read instruction sequences can be broken up by inserting a non-Flash read instruction (such as a `NOP`), in between the Flash read instructions; or
4. The alignment of the code can be shifted to avoid the required opcode location addresses.
