Product Change Notification - SYST-10IADJ364

ERRATA - dsPIC33EPXXGS202 Family Silicon Errata and Data Sheet Clarification

dsPIC33EPXXGS202 Family Silicon Errata and Data Sheet Clarification

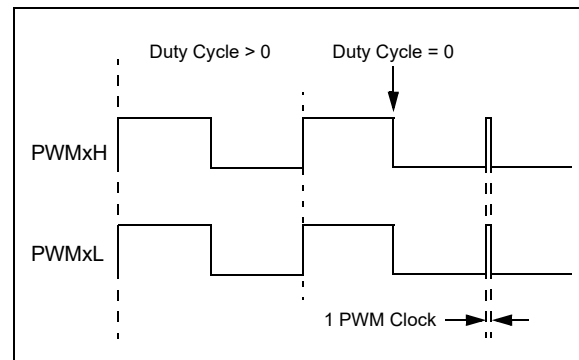
FIGURE 1: EXAMPLE FOR REDUNDANT OUTPUT MODE

In the Redundant Output mode (`IOCONx[11:10] = 0b01`) and Push-Pull Output mode (`IOCONx[11:10] = 0b10`), with the Immediate Update Enable bit disabled (`PWMCONx[0] = 0`), when the Duty Cycle register is updated from a non-zero value to zero, a glitch pulse of a width equal to one PWM clock will appear at the next PWM period boundary, as shown in Figure 1 (for the Redundant Output mode). The Duty Cycle register refers to the `PDCx` register if `PWMCONx[8] = 0` or the `MDC` register if `PWMCONx[8] = 1`.

If the application requires a zero duty cycle output, there are two possible work around methods:

1. Use the PWM override feature to override the PWM output to a low state instead of writing to the Duty Cycle register. In order to switch back to a non-zero duty cycle output, turn off the PWM override. The override-on and override-off events must be timed close to the PWM period boundary if the `IOCONx` register has been configured with `IOCONx[0] = 0` (i.e., output overrides through the `OVDDAT[1:0]` bits occur on the next CPU clock boundary).
2. Enable the Immediate Update Enable bit (`PWMCONx[0] = 1`) while configuring the PWMx module (i.e., before enabling the PWMx module, `PTCON[15] = 1`). With the Immediate Update enabled, writes to the Duty Cycle register can have an immediate effect on the PWM output. Therefore, the duty cycle write operations must be timed close to the PWM period boundary in order to avoid distortions in the PWM output.

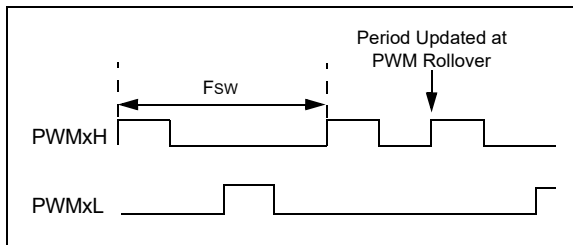
FIGURE 2:

When the PWM module is configured for Push-Pull mode (IOCONx[11:10] = 0b10) with the Enable Immediate Period Update bit enabled (PTCON[10] = 1), a write to the Period register that coincides with the period rollover event may cause the push-pull output logic to produce back-to-back pulses on the PWMx pins (Figure 2).

If the EIPU bit is set (PTCON[10] = 1), ensure that the update to the PWM Period register occurs away from the PWM rollover event. Use either the PWM Special Event Trigger (SEVTCMP) or the PWM Primary Trigger (TRIGx) to generate a PWM Interrupt Service Routine (ISR) near the start of the PWM cycle. The PWM Period register could be updated inside this ISR so that the period writes do not occur near the PWM period rollover event.

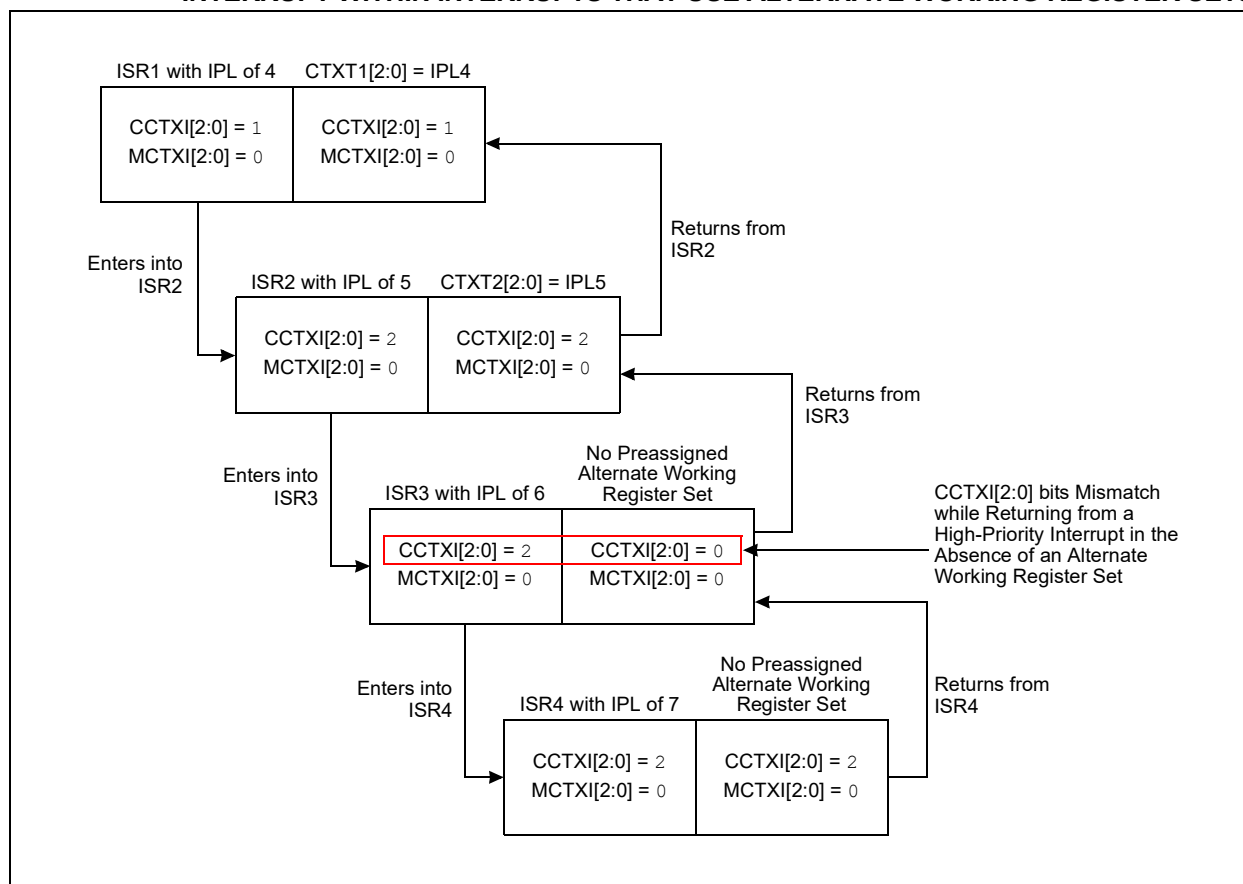
FIGURE 3: MISMATCH OF WORKING REGISTER SET WHEN NESTING MORE THAN ONE INTERRUPT WITHIN INTERRUPTS THAT USE ALTERNATE WORKING REGISTER SETS

Issue and work around are illustrated in [Figure 3](#) and [Figure 4](#), respectively. The figures show the status bits, `CCTXI[2:0]` and `MCTXI[2:0]`, after entering into an ISR from a lower priority ISR (left pane), and after returning to the same ISR from a higher priority ISR (right pane).

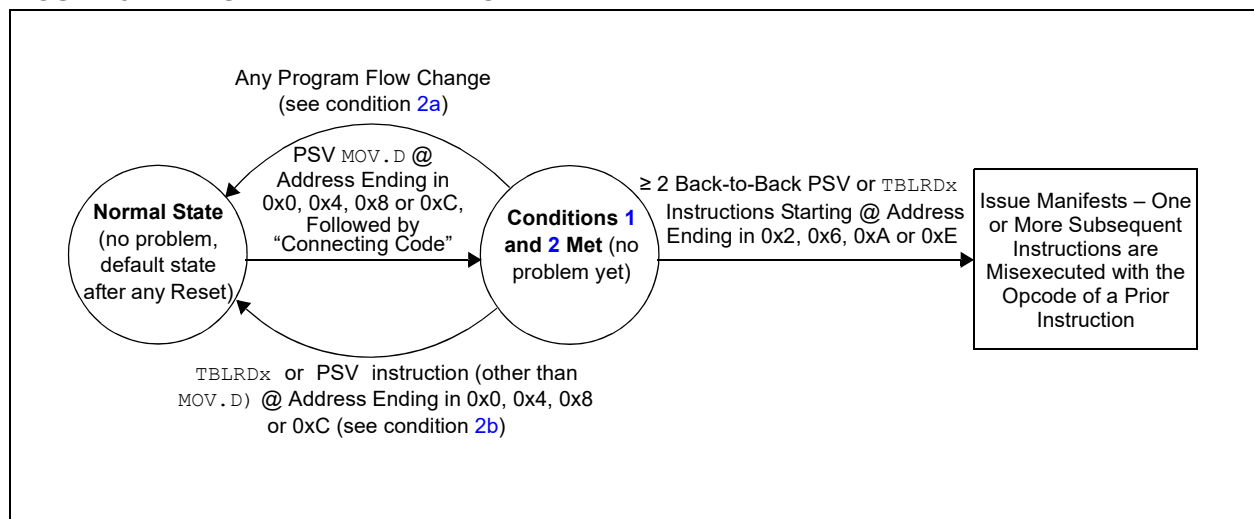
FIGURE 5: SIMPLIFIED BEHAVIOR

When two or more data Flash read instructions (via Program Space Visibility (PSV) read or table read) are executed back-to-back, one or more subsequent instructions can be misexecuted when all of the conditions in [Table 4](#) occur.

[Figure 5](#) provides an example of the effective behavior.

1. All instances of PSV MOV.D can be replaced with two PSV MOV instructions instead. Non-PSV MOV.D instructions acting on RAM/SFRs do not need to be modified; or
2. If not already present, a program flow change instruction (such as BRA \$+2) can be inserted above back-to-back data Flash read sequences; or
3. Back-to-back data Flash read instruction sequences can be broken up by inserting a non-Flash read instruction (such as a NOP), in between the Flash read instructions; or
4. The alignment of the code can be shifted to avoid the required opcode location addresses.

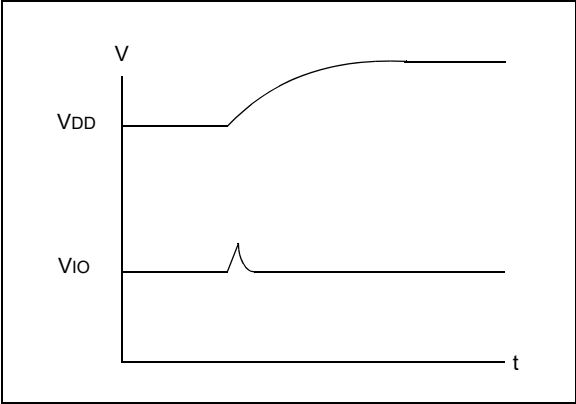
FIGURE 6: I/O RAMP

During device power-up, the I/O pins may drive up to 100 μ A current for a duration of up to 300 μ S. (Figure 6).

Ensure the circuitry that is connected to the pins can endure this pulse.
