## Product Change Notification - SYST-16MXTC292

ERRATA - dsPIC33CK256MP508 Family Silicon Errata and Data Sheet Clarification Errata Document Revision

## dsPIC33CK256MP508 Family Silicon Errata and Data Sheet Clarification

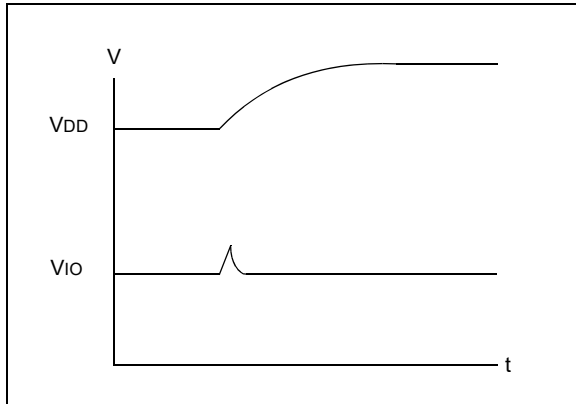
FIGURE 1-1: I/O RAMP

During a fast device power-up when the VDD ramp is less than 4 mS, the I/O pins may drive up to 100  $\mu$ A current for a duration of up to 10  $\mu$ S (Figure 1-1).

Example applications affected may include complementary power switches, where a transient current shoot-through might occur. High-voltage applications with complementary switches should power the high-voltage 200  $\mu$ Sec later than powering the dsPIC<sup>®</sup> device to avoid the current shoot-through. This behavior is specific to each device and not affected by aging.

1. Slow down the VDD ramp time (greater than 4 mS for VDD to ramp 0V to 3.3V).
2. Ensure the circuitry that is connected to the pins can endure this pulse.
