## Product Change Notification - SYST-13VHLJ680

ERRATA - dsPIC33FJ32GS406/606/608/610 and dsPIC33FJ64GS406/606/608/610 Silicon Errata and Document Clarification Document Revision

## dsPIC33FJ32GS406/606/608/610 and dsPIC33FJ64GS406/606/608/610 Family Silicon Errata and Data Sheet Clarification

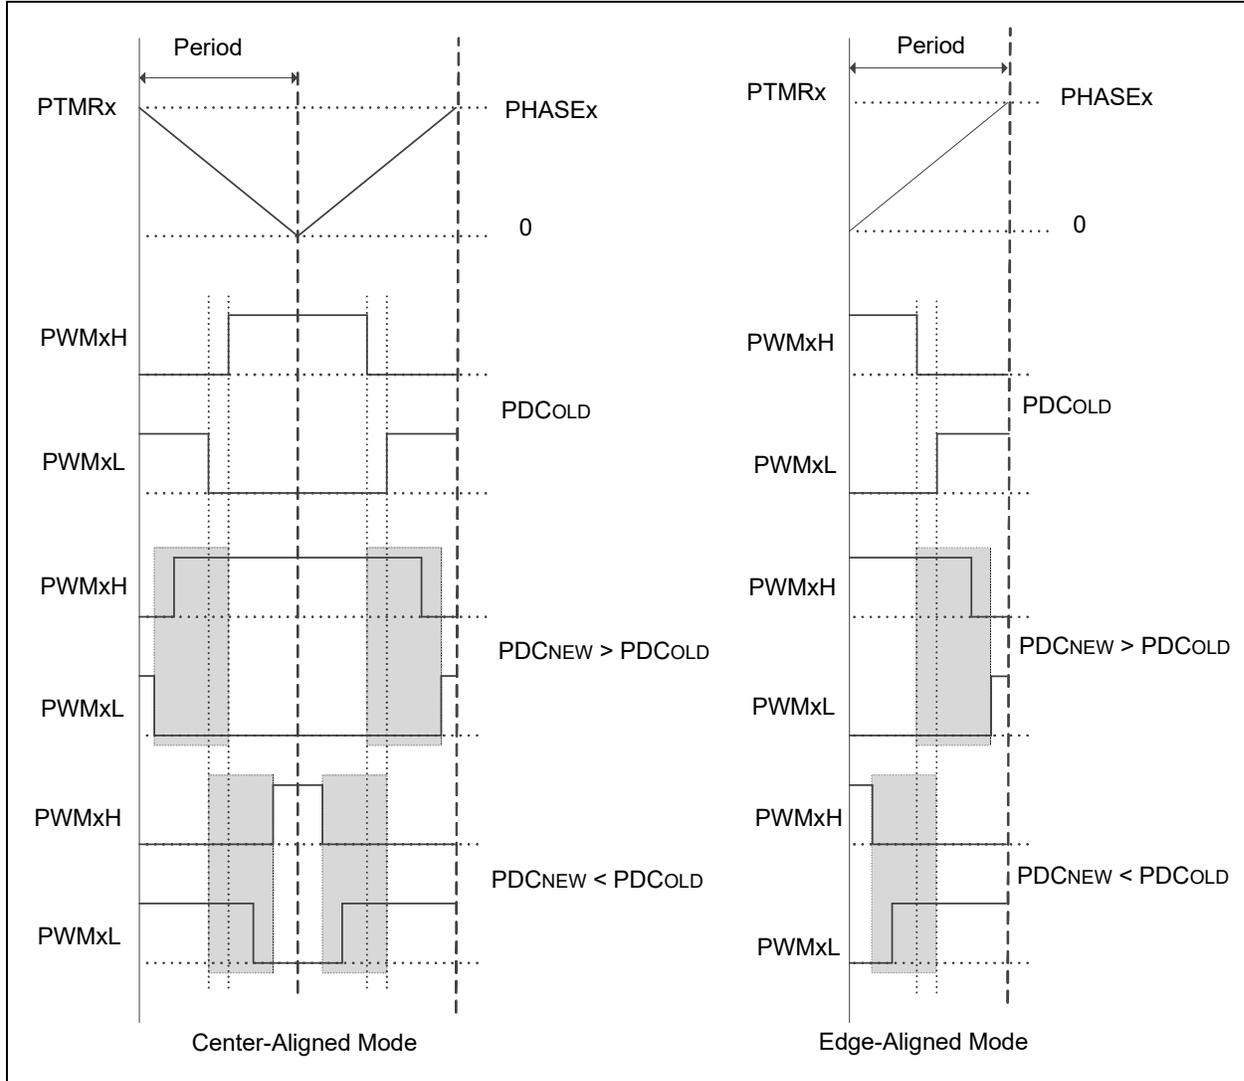
FIGURE 1: TIMING DIAGRAMS FOR CENTER-ALIGNED AND EDGE-ALIGNED MODES

The PWMx generator may not assert dead time on the edges of transitions. This has been observed when all of the following conditions are present:

In [Figure 1](#) (following page), if the duty cycle write occurred in the shaded box, then PWMxH and PWMxL will make an immediate transition without dead time.

None. However, in most applications the duty cycle update timing can be controlled using the TRIGx trigger or Special Event Trigger, such that the above mentioned conditions are avoided altogether.

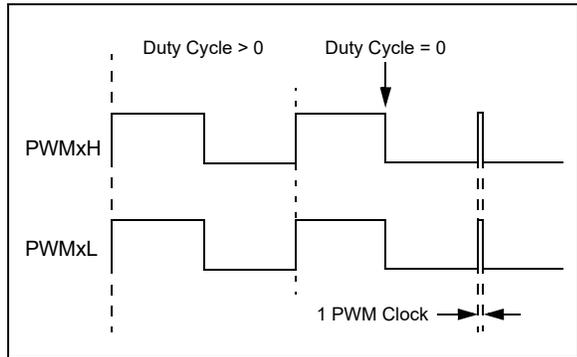
**FIGURE 2: ISSUE EXAMPLE FOR REDUNDANT OUTPUT MODE**

In Redundant Output mode (IOCONx[11:10] = 01) and Push-Pull Output mode (IOCONx[11:10] = 10), with the Immediate Update Enable bit disabled (PWMCONx[0] = 0), when the Duty Cycle register is updated from a non-zero value to zero, a glitch pulse of a width equal to one PWM clock will appear at the next PWM period boundary, as shown in Figure 2 (for the Redundant Output mode). The Duty Cycle register refers to the PDCx register if PWMCONx[8] = 0 or the MDC register if PWMCONx[8] = 1.

If the application requires a zero duty cycle output, there are two possible work around methods:

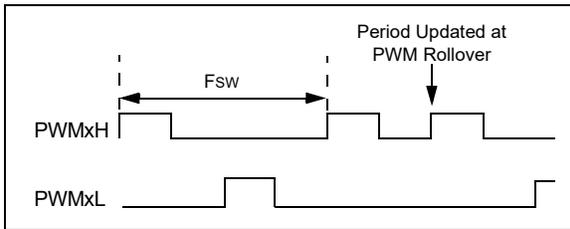
**FIGURE 3:**

When the PWM module is configured for Push-Pull mode (IOCONx[11:10] = 10) with the Enable Immediate Period Update bit enabled (PTCON [10] = 1), a write to the Period register that coincides with the period rollover event may cause the push-pull output logic to produce back-to-back pulses on the PWMx pins (Figure 3).

Ensure that the update to the PWM Period register occurs away from the PWM rollover event by setting the EIPU bit (PTCON[10] = 1). Use either the PWM Special Event Trigger (SEVTCMP) or the PWM Primary Trigger (TRIGx) to generate a PWM Interrupt Service Routine (ISR) near the start of the PWM cycle. This ISR will ensure that period writes do not occur near the PWM period rollover event.

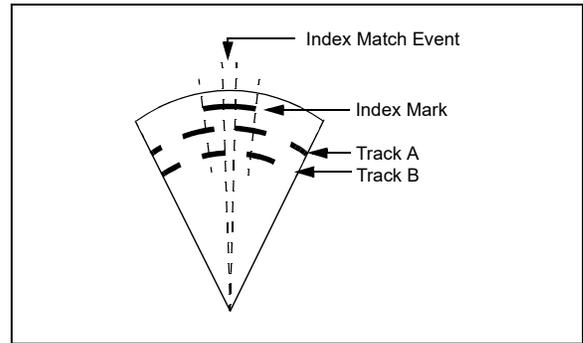
**FIGURE 4: ENCODER IN THE SECTOR AROUND THE INDEX MARK**

This issue is most likely to be seen in specific motor applications using a rotation encoder with an ungated index pulse, operating at near zero speed and/or in the presence of mechanical vibration. In these applications, the encoder may change direction and incrementally rock back and forth. If this happens with the encoder positioned in the vicinity of its index mark, the module will detect the first index match event as the encoder rotates into the index match event area, but not subsequent events if it drifts into and out of that position but stays within the index mark area (Figure 4). If the encoder count increments or decrements in only one direction, the index match will only occur once.

As a result of this, the value of POSxCNT may leave its expected range of 0 to maximum count (defined as the number of encoder pulses per revolution, minus 1), resulting in erroneous reporting of the rotor's position.

None.

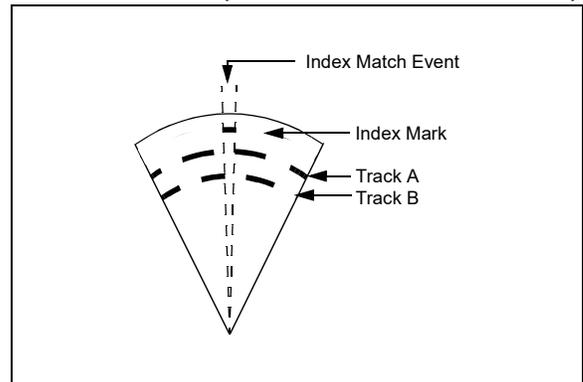
**FIGURE 5: ENCODER IN THE SECTOR AROUND THE INDEX MARK (ONE COUNT WIDTH INDEX)**

This issue is not seen when the encoder uses an index mark that is one encoder count in width (Figure 5).
