## Product Change Notification - SYST-21HDIC684

ERRATA - PIC32MX534/564/664/764 Family Silicon Errata and Data Sheet Clarification

## PIC32MX534/564/664/764 Family Silicon Errata and Data Sheet Clarification

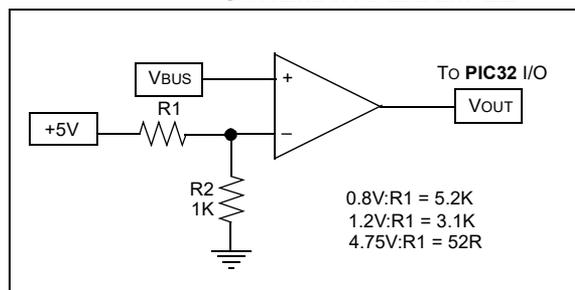
FIGURE 1: EXTERNAL COMPARATOR SCHEMATIC EXAMPLE

When the USB model is configured for OTG operation, it may not recognize all required OTG voltage levels on VBUS pin.

Use external comparator circuit to detect OTG specific voltage levels on VBUS pin.
