Product Change Notification - SYST-09HZSA980

ERRATA - PIC32MZ Embedded Connectivity with Floating Point Unit (EF) Family Silicon Errat

PIC32MZ Embedded Connectivity with Floating Point Unit (EF) Family Silicon Errata and Data Sheet Clarification

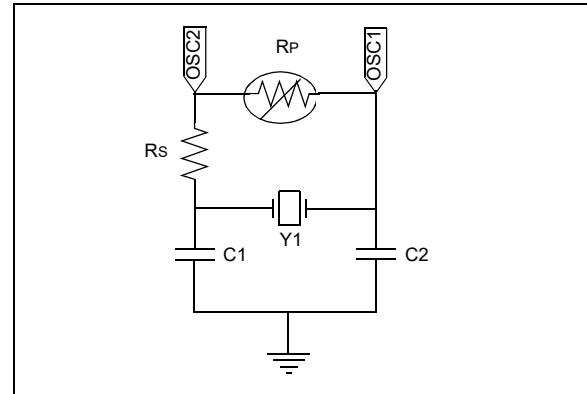
FIGURE 1: Posc CRYSTAL CIRCUIT

Revision A1 Silicon: A crystal oscillator cannot be used as an input to the Primary Oscillator (Posc) pins OSC1 and OSC2.

Revision A3 and B2 Silicon: The Posc has been tested in a normal power-up sequence and supports specific crystal operation.

The Primary Oscillator (Posc) has been characterized to operate at 8 MHz, 12 MHz, and 24 MHz when the circuit in [Figure 1](#) is implemented, and the operating conditions listed in [Table 3](#) are met.

Note 1: Using any other crystal frequency will require special component selection and characterization.
2: A parallel resistor (Rp) should not be used to increase the gain of the POSC.
