PCN Number: 1404  
Chgnot.doc rev 13 1/14

**Product/Process Change Notification (PCN)**

This improvement consists of two changes to the current packaging for the CA/CB package family: a change to the design of the end pin and a change to the size of the tube pin hole.

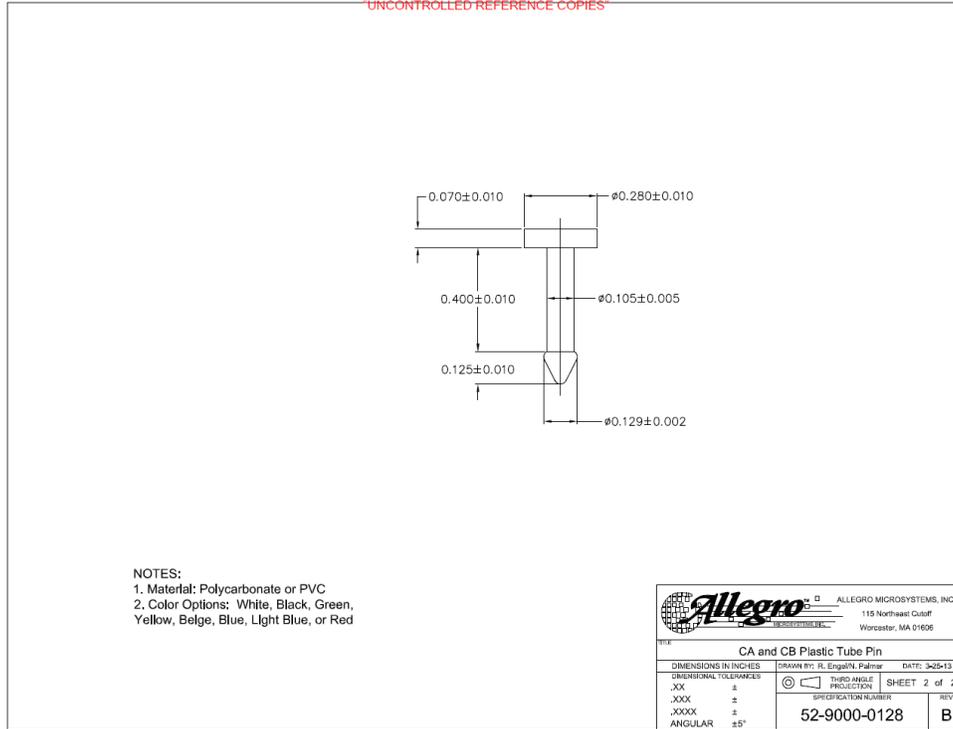
### Current Pin Design Drawing: 52-9000-0128 Rev B

Comparison images of the old pin and new pin design can be found in the chart below. More detailed drawings can be found in Appendix A. The new pin design uses a soft PVC material which has more elasticity to absorb shock during transportation. The new pin is much thicker in diameter which prevents the devices from shifting within the tubes during shipment.

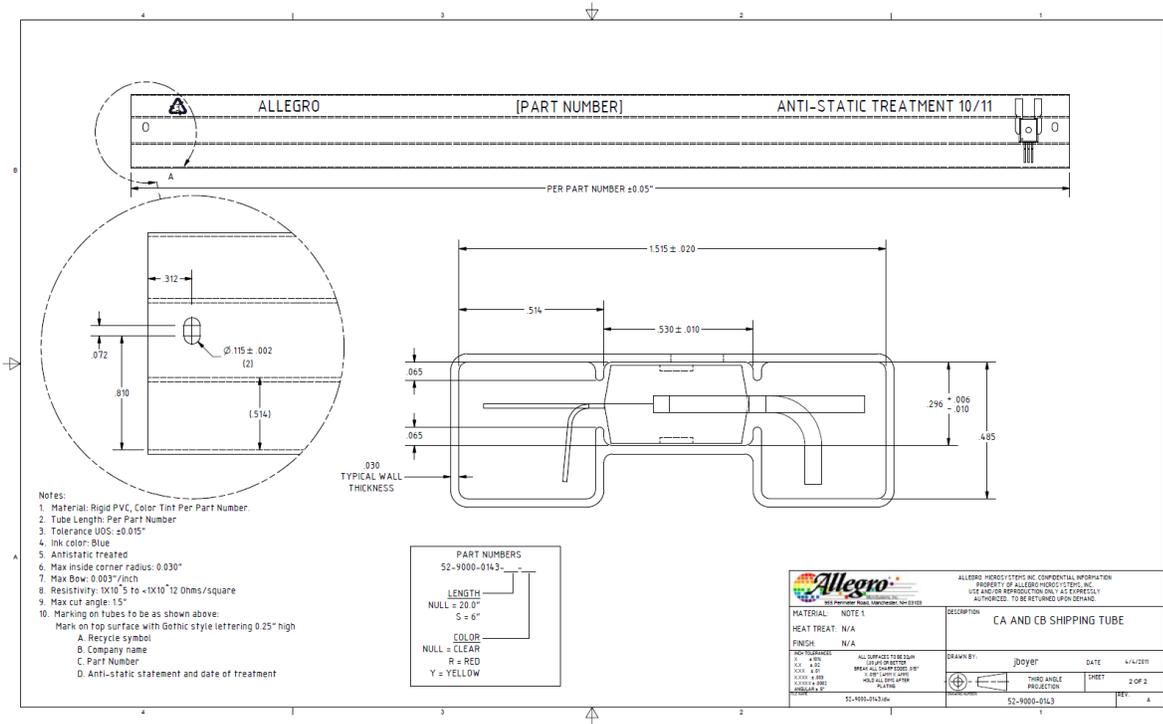
Current Tube Design Drawing: 52-9000-0143 Rev A

Comparison images of the old and new tube pinholes can be found in the chart below. More detailed comparison drawings of the full tube design can be found in Appendix B. The pinholes on either end of the tube have been widened and elongated to allow for the larger soft PVC pins. No other changes have been made to the tube design. This improvement also has no effect on the quantity of devices per tube, number of tubes per box, or any other general packing procedures.

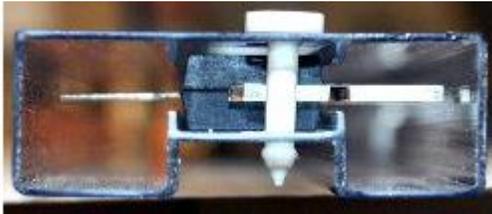
*Exhibit 1*

Inner boxes 1 and 3 contained devices packaged in the old tube design (Exhibit 1). Inner boxes 2 and 4 contained devices packaged in the new tube design (Exhibit 2). See Exhibit 3 for the layout of these inner boxes within the outer box.

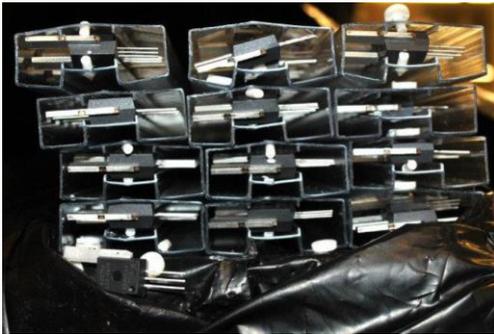
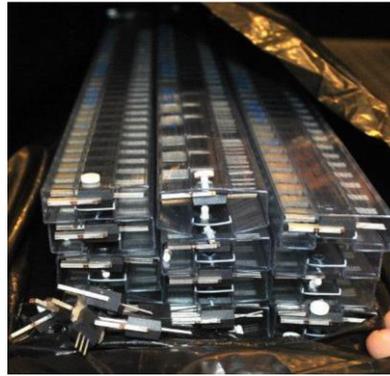
*Exhibit 4*

After the outer box was dropped 10 times on each end and each side for a total of 40 drops, inner boxes 1 and 3 showed 100% shearing and a large amount of device disorientation (Exhibit 4). Inner boxes 2 and 4 showed no issues (Exhibit 5).
